# **FULL QUINQUENNIAL PROPERTY SURVEY**

## **EAST KILBRIDE: WESTWOOD**

## **PRESBYTERY OF HAMILTON**

**October 2019**

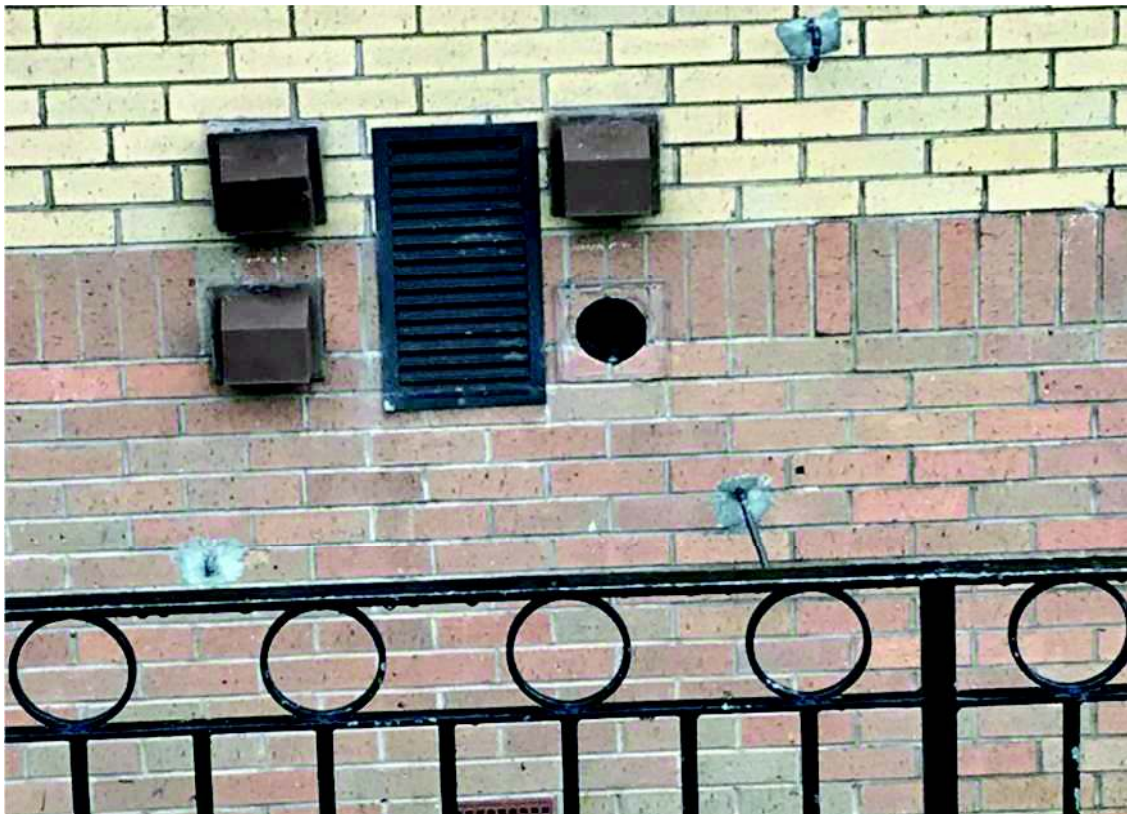
One of the vent covers is missing (photo 13) and should be replaced to prevent vermin/bird access.

| Element | Description | Condition | | | Recommended repairs | Priority | | | Indicative Costs | | | | | |
|---|---|---|---|---|---|---|---|---|---|---|---|---|---|---|
| | | X | | | | Some external vent cowls missing - replace to prevent vermin/bird access | X | | £ | 50 | £ | - | | |

13 Missing vent cover

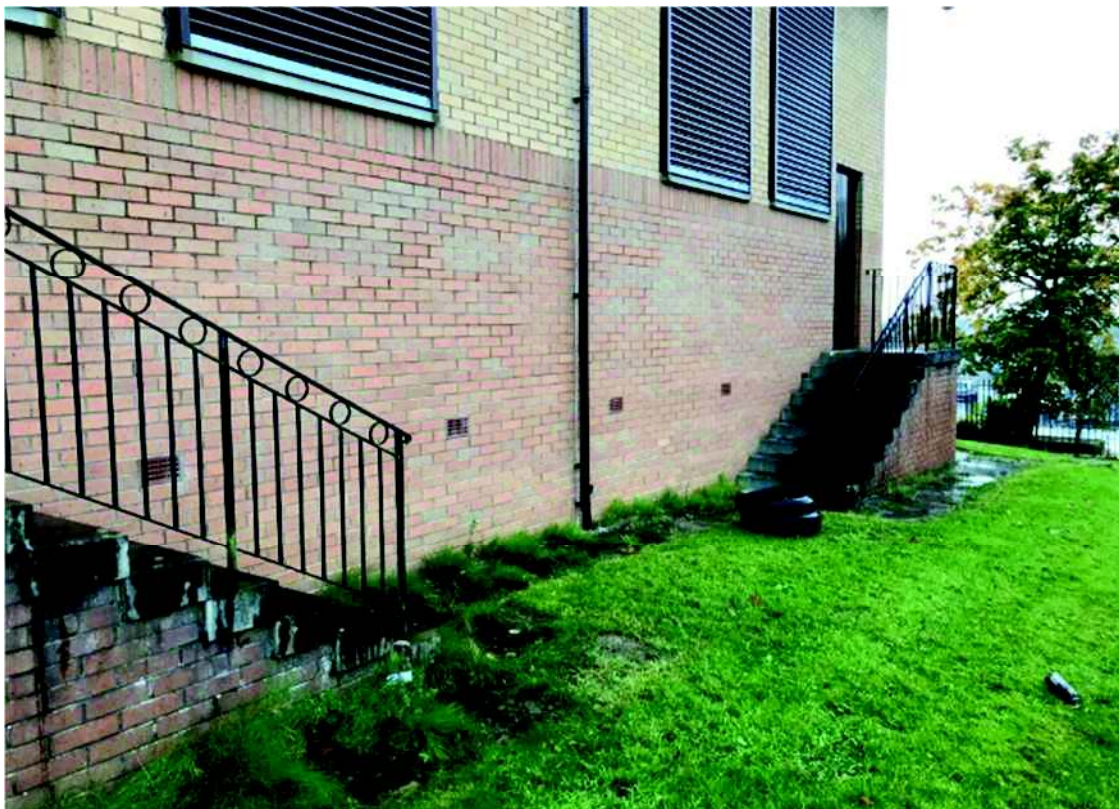
At the rear of the sanctuary, there are two means of escape which converge in one location (photo 14). However, the path at this location is only one slab wide, and against the building. The landing area should be extended to provide a greater area of hardstanding and a footpath (minimum 1200 wide) to link to the front.

| Element | Description | Condition | | | Recommended repairs | Priority | | | Indicative Costs | | | | | |
|---|---|---|---|---|---|---|---|---|---|---|---|---|---|---|
| | Fire escape from sanctuary | X | | | | Two means of escape converge on single path which is only one slab wide, then onto grass. Extend slabbed area to connect to path at side, leading to gate | | X | £ | - | £ | 3,000 | | |

14 Poor arrangement at fire escape from sanctuary - only single row of slabs then grass area

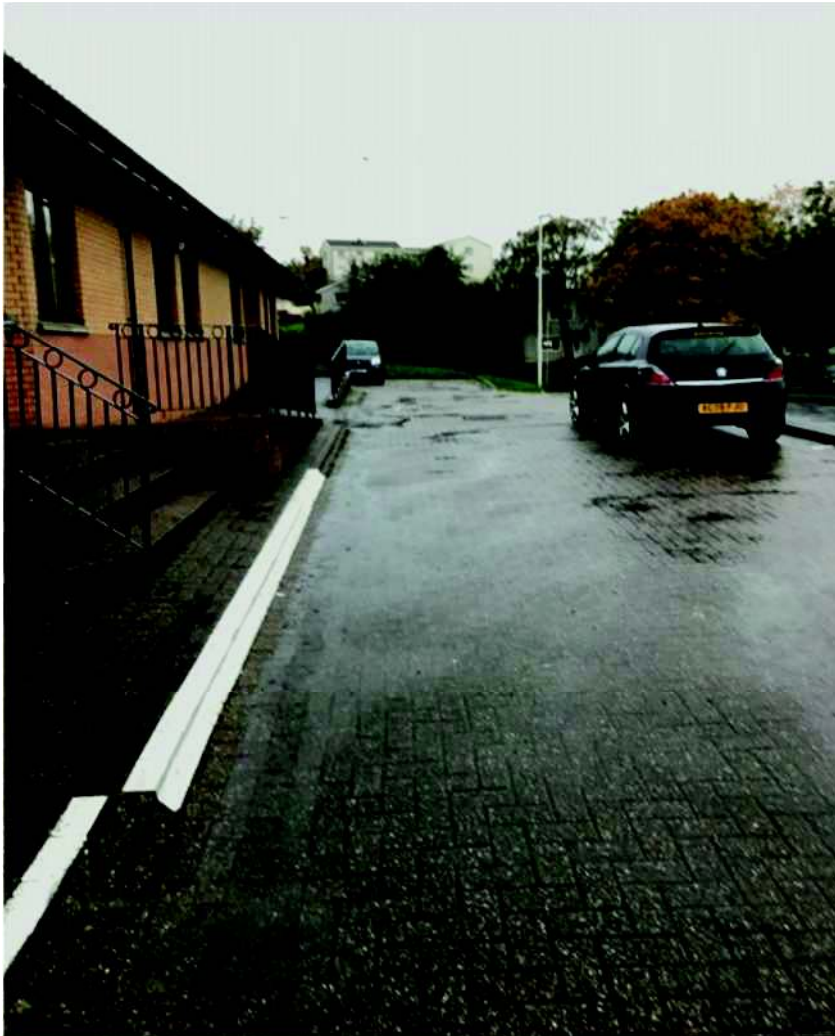
| Element | Description | Condition | | | Recommended repairs | Priority | | | Indicative Costs | | | | | |
|---|---|---|---|---|---|---|---|---|---|---|---|---|---|---|
| Car parking | Monobloc area supplemented by on street and adjacent public car parks | | X | | | Movement over time in monobloc has resulted in several raised edges at manholes etc which are trip hazards. Plan for lifting and relaying monobloc to provide level access | | X | £ | - | £ | 9,000 | | |

15 Monobloc sunk in various locations with trip hazards at manhole covers etc

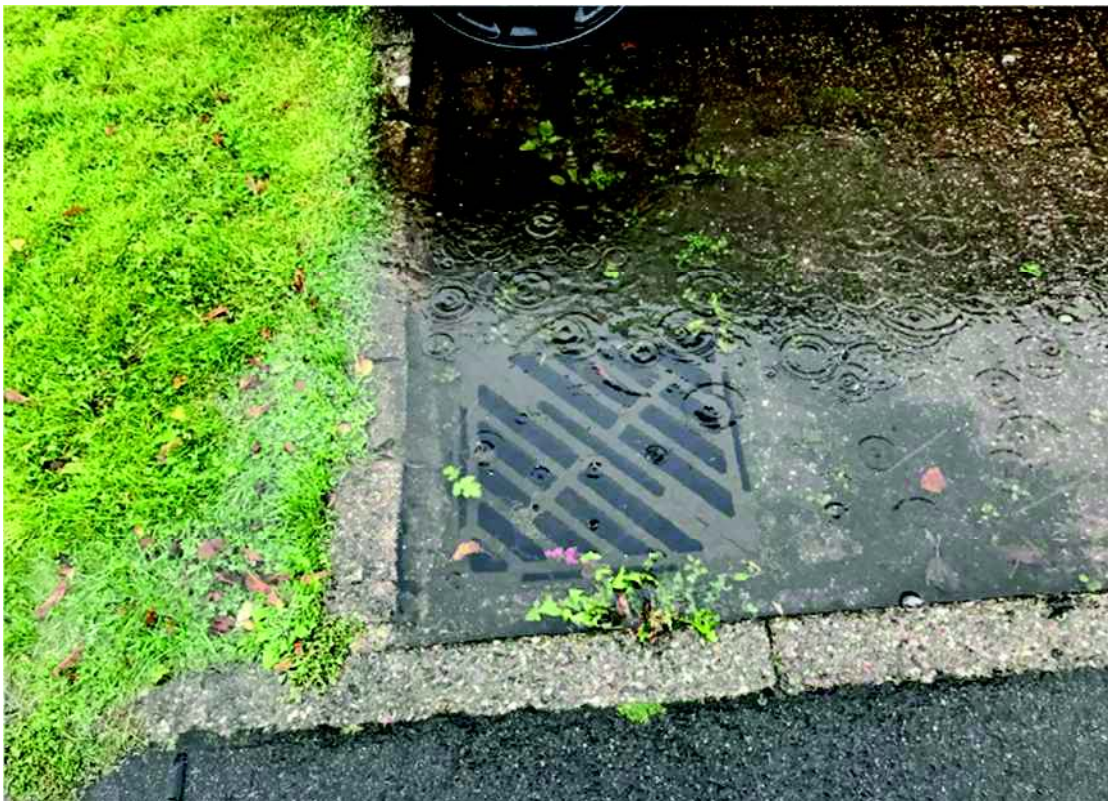
16 Car park gullies blocked

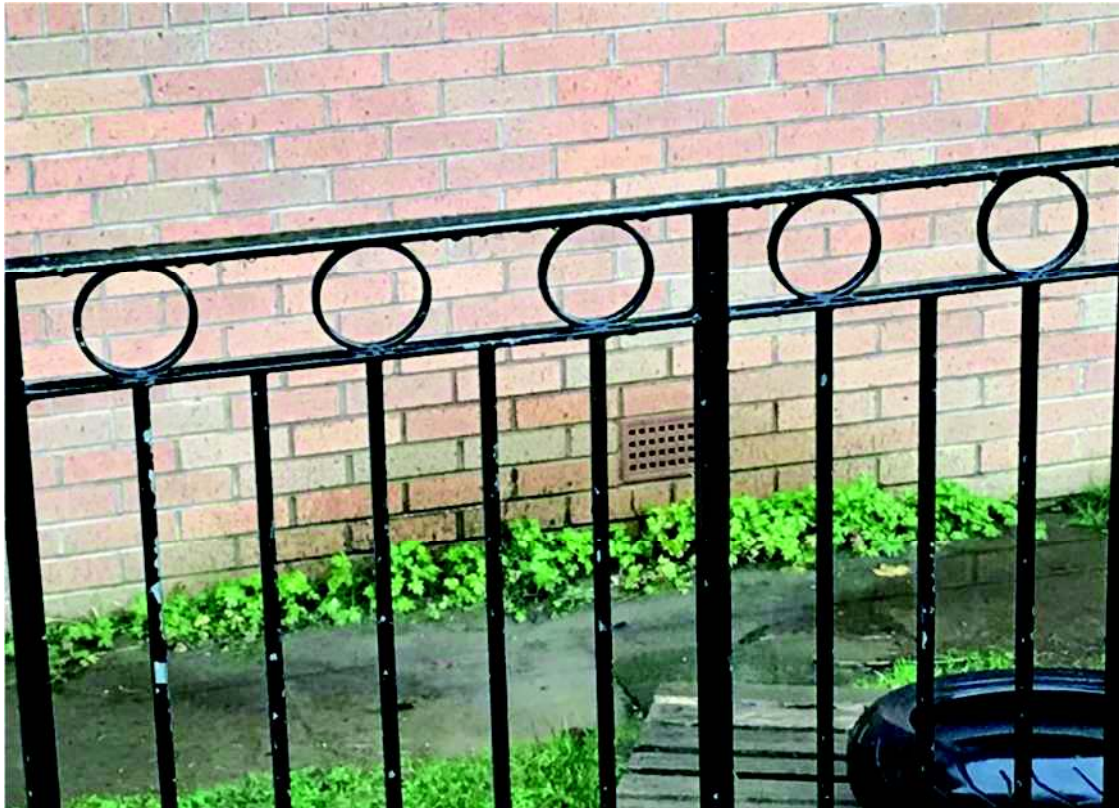
17 Check if ponding due to surface water run off from grass or from leak in gutter or below slabs

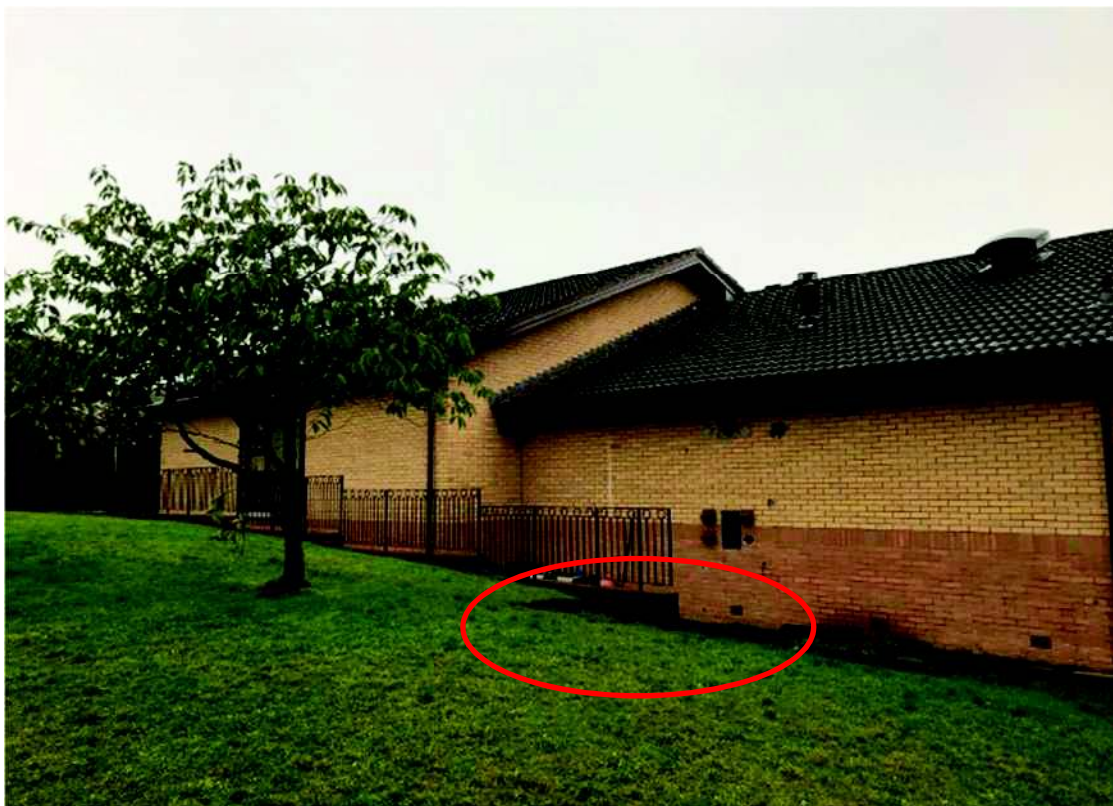
| Element | Description | Condition | | | Recommended repairs | Priority | | | Indicative Costs | | | | | |
|---|---|---|---|---|---|---|---|---|---|---|---|---|---|---|
| Landscaping | Grass and shrubs | | X | | | Area of soil at end of retaining wall has eroded. Consider extended wall or dressing back ground level in this location | | | £ | - | £ | - | | |

18 Area highlighted suffers from soil erosion at end of retaining wall. Consider installation of steps or re-dressing surface levels

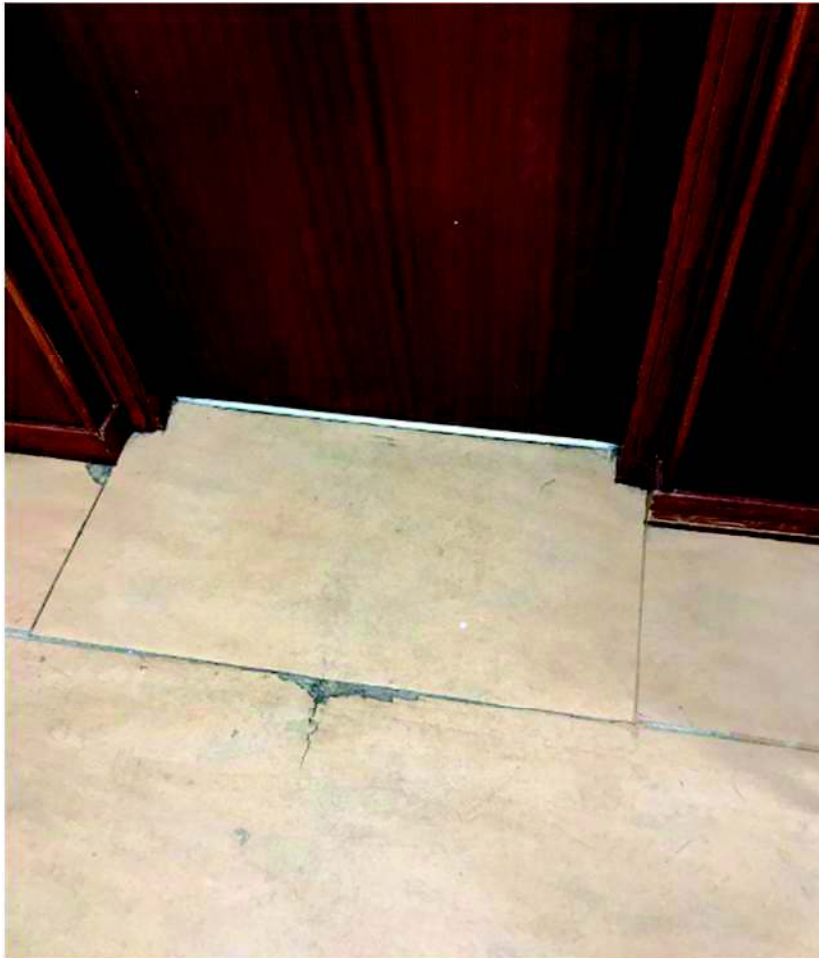
| Element | Description | Condition | | | Recommended repairs | Priority | | | Indicative Costs | | | |
|---|---|---|---|---|---|---|---|---|---|---|---|---|
| Floors | Vinyl | | X | | | Area at fire door defective; repair in this location | | X | £ | - | £ | 1,000 |

19 Damaged flooring at fire escape door in Duncanrig Hall

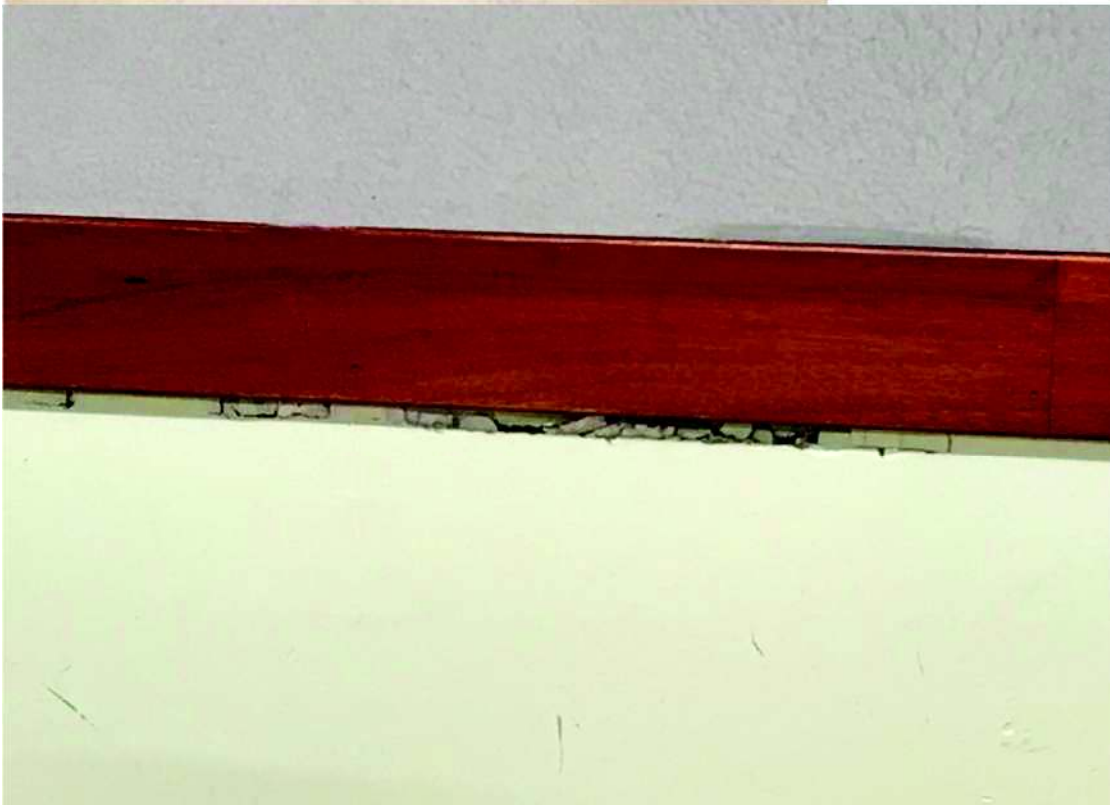
| Element | Description | Condition | | | Recommended repairs | Priority | | | Indicative Costs | | | |
|---|---|---|---|---|---|---|---|---|---|---|---|---|
| Walls | Plaster, painted; timber chair rail | | X | | | Area of plaster below chair rail damaged. Repair plaster and consider introducing timber panel or bead in this area | | X | £ | - | £ | 750 |

20 Damaged plaster below chair rail (rail is above height of tables)

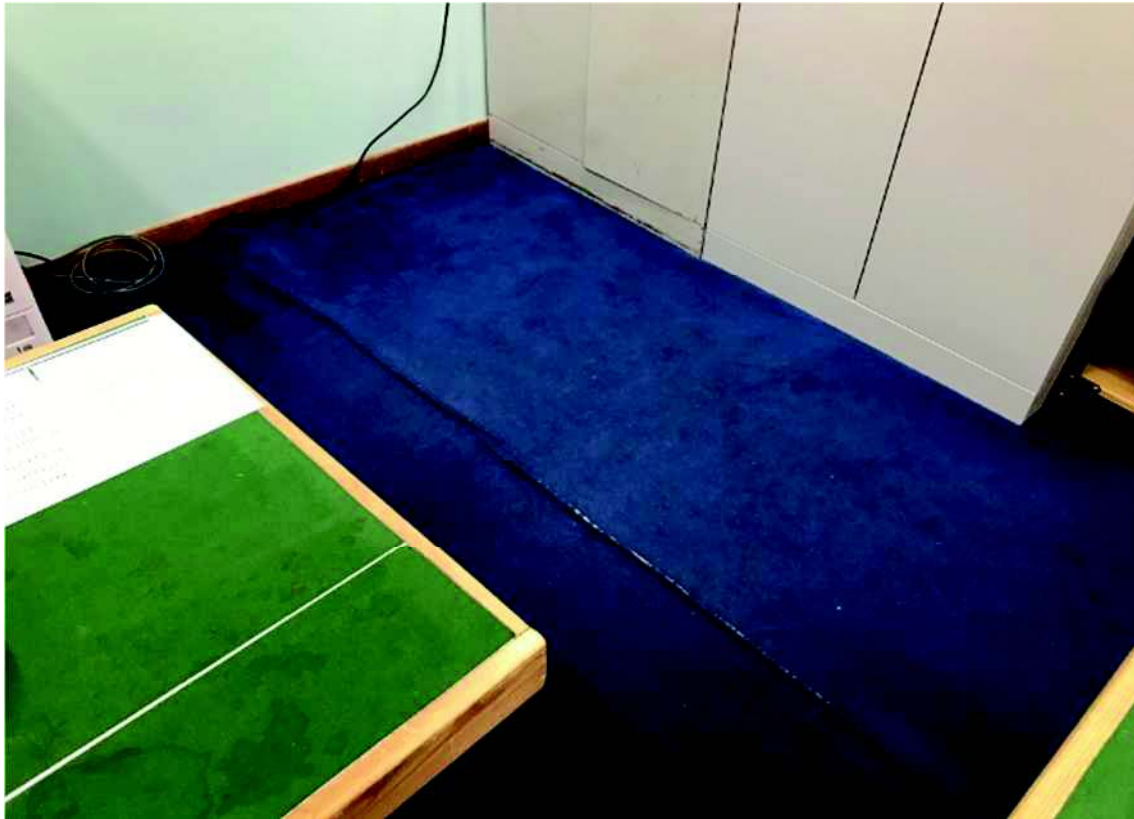
| Element | Description | Condition | | ✓ | Recommended repairs | Priority | | Indicative Costs | | |
|---|---|---|---|---|---|---|---|---|---|---|
| Floors | Carpet | X | | | Carpet has crease in middle due to lifting/re-laying for cabling. Uplift carpet to remove trip hazard. In time, consider replacing floor finish | X | | £ | 50 | £ |

21 Crease in carpet in office

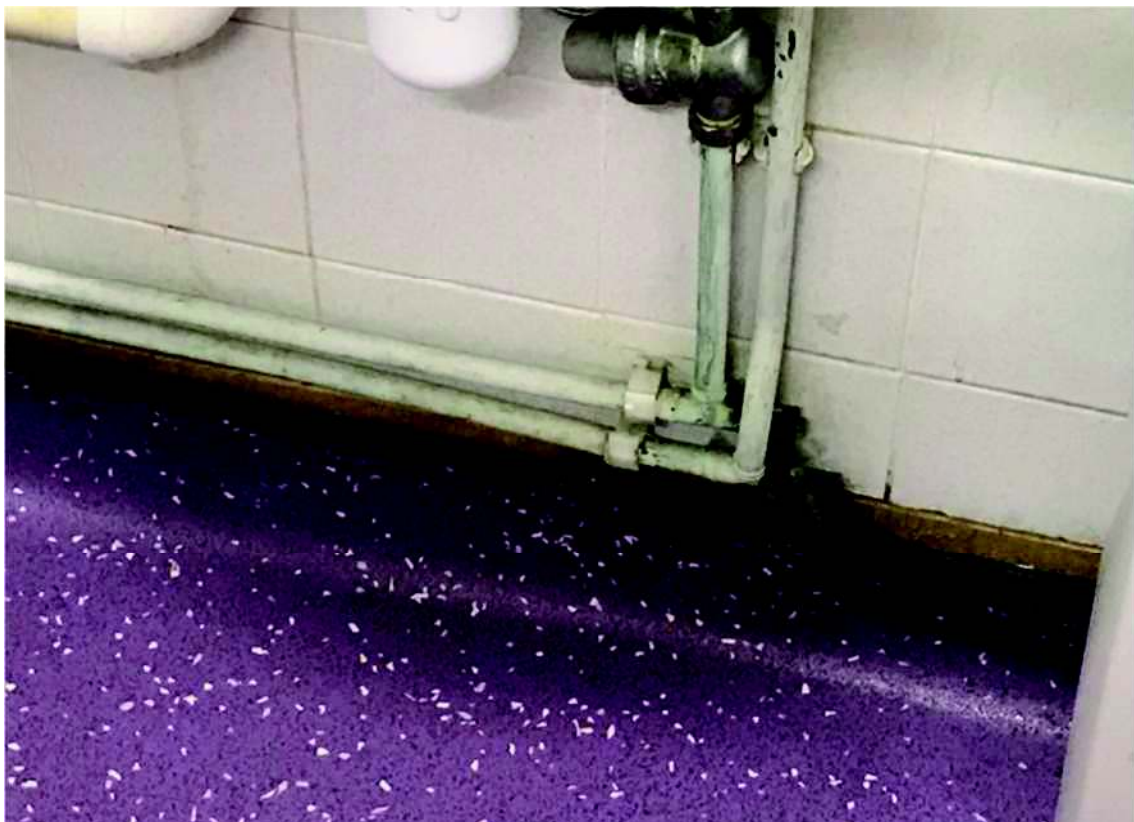
22 Dressed up skirting losing adhesion in accessible toilet

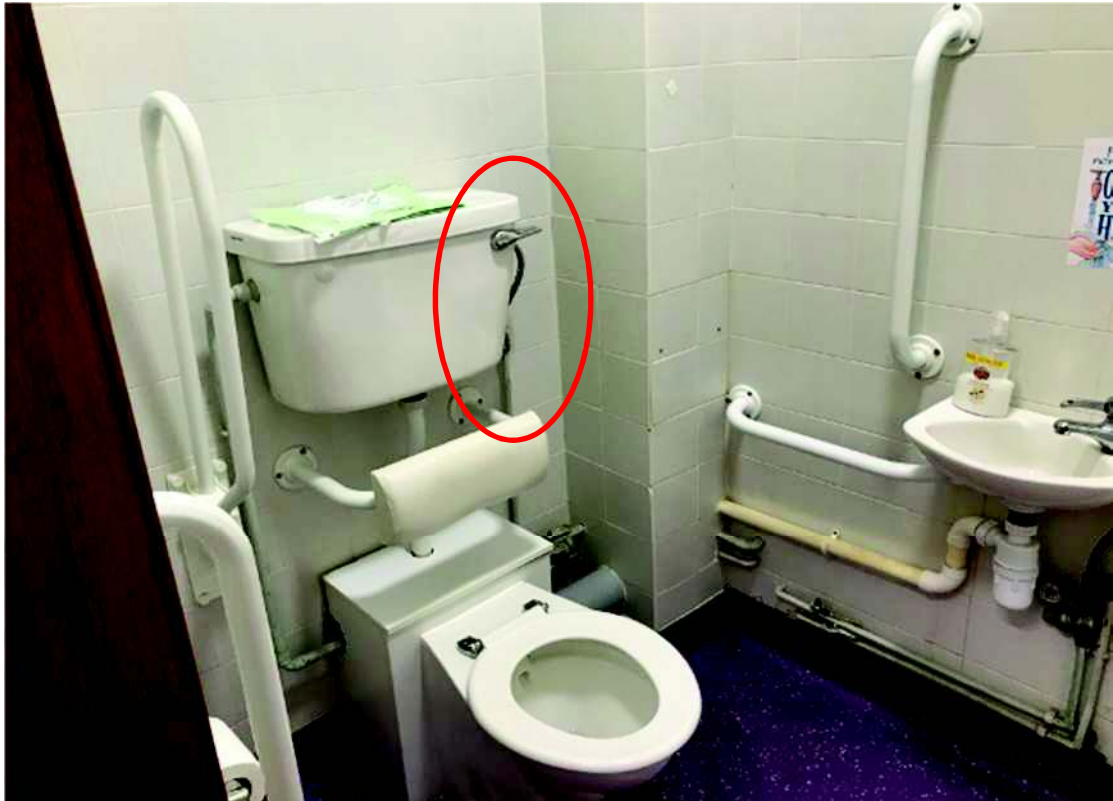
| Element | Description | Condition | | | ✓ | Recommended repairs | Priority | | | Indicative Costs | | | | | | | |
|---|---|---|---|---|---|---|---|---|---|---|---|---|---|---|---|---|---|
| Plumberwork | Copper pipework generally | | X | | | Connections to wc cisterns are in small bore flexi pipe which are undersized for quick fill. Replace with larger pipe or fixed pipework | | X | | £ | - | £ | 450 | | | | |

23 Flexi connectors at cisterns undersized causing delay in fill

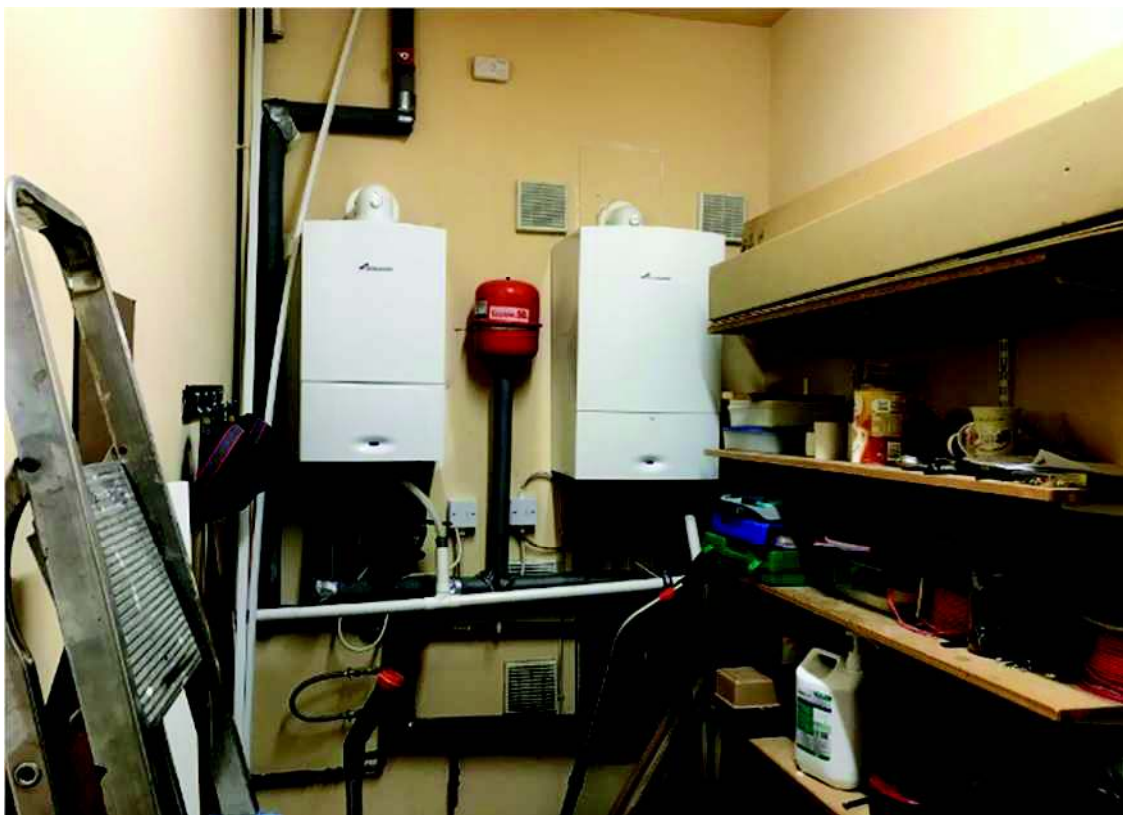
24 Boiler room - keep clear of combustible materials

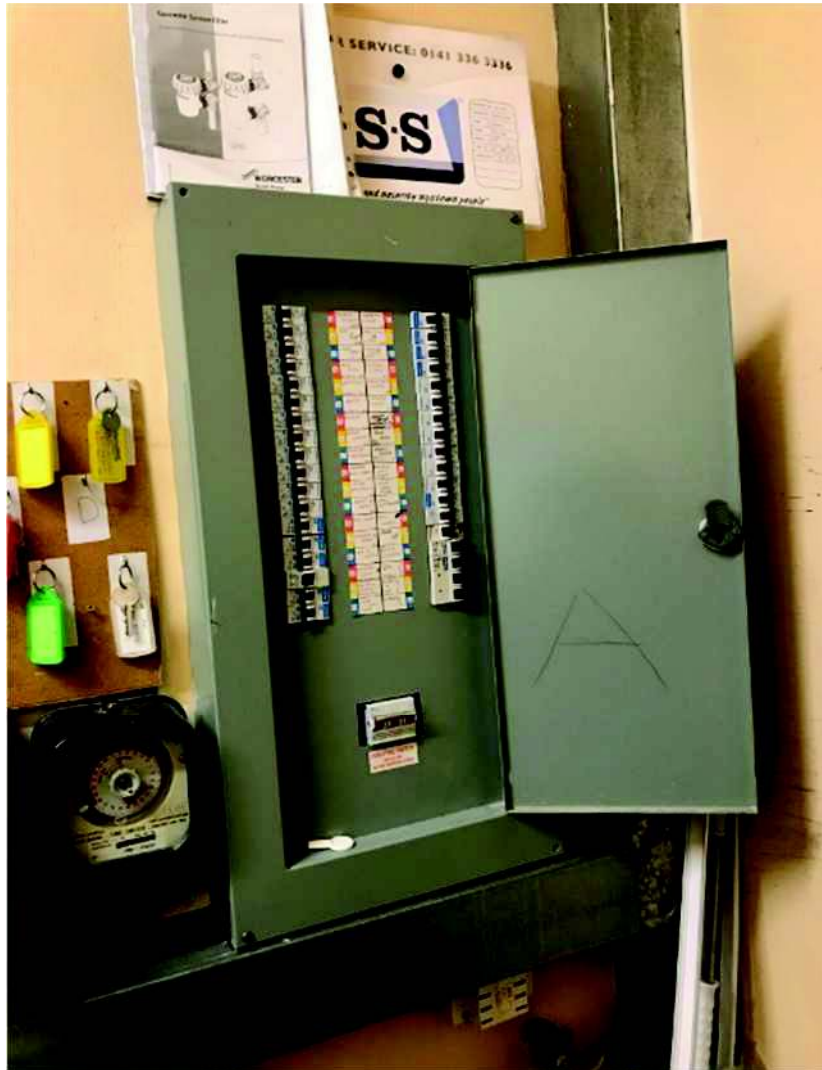
Consideration should be given to replacing the main switchboard (photo 25) as the existing one is now at full capacity. The switchboard is located within the boiler room – this room should be kept clear of all combustible materials (photo 24).

25 Main switchboard has no spare capacity

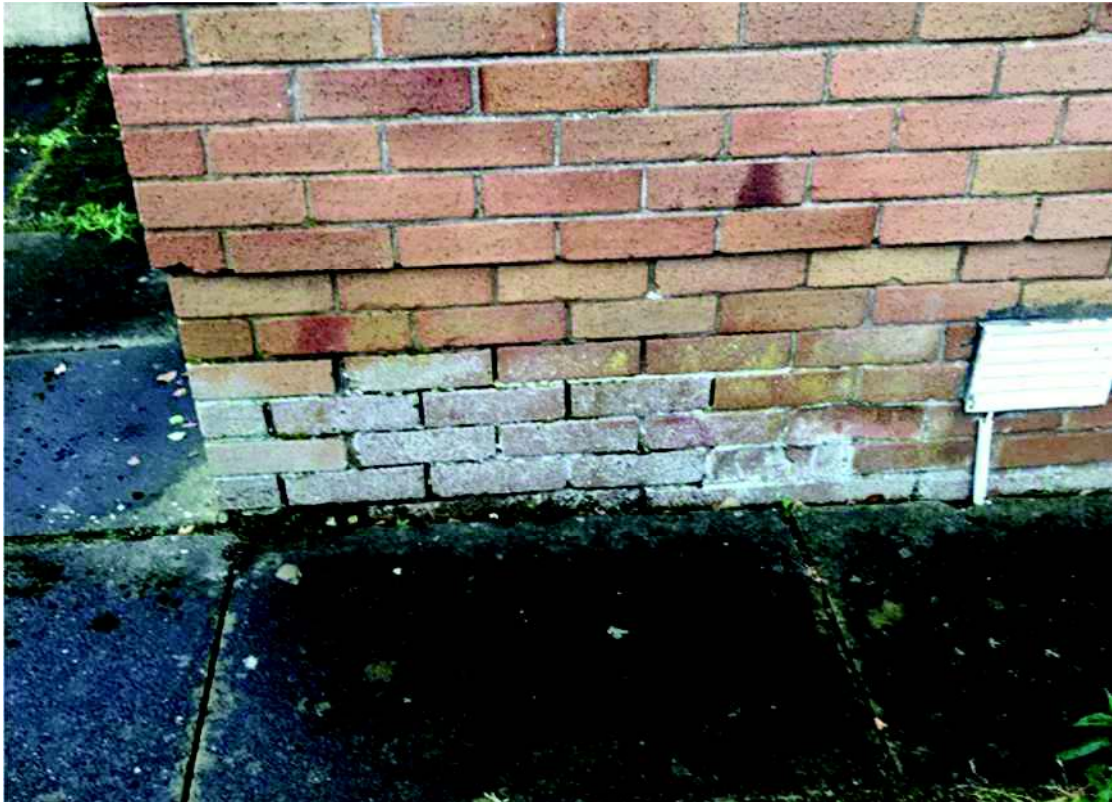
There appear to be issues with the below ground drainage which should be inspected and cleared as required. The gutter on the return at the lounge overflows and there is a build up of efflorescence in this location too (photo 26).

26 Efflorescence at corner at front - drainage appears blocked as gutter overflowing

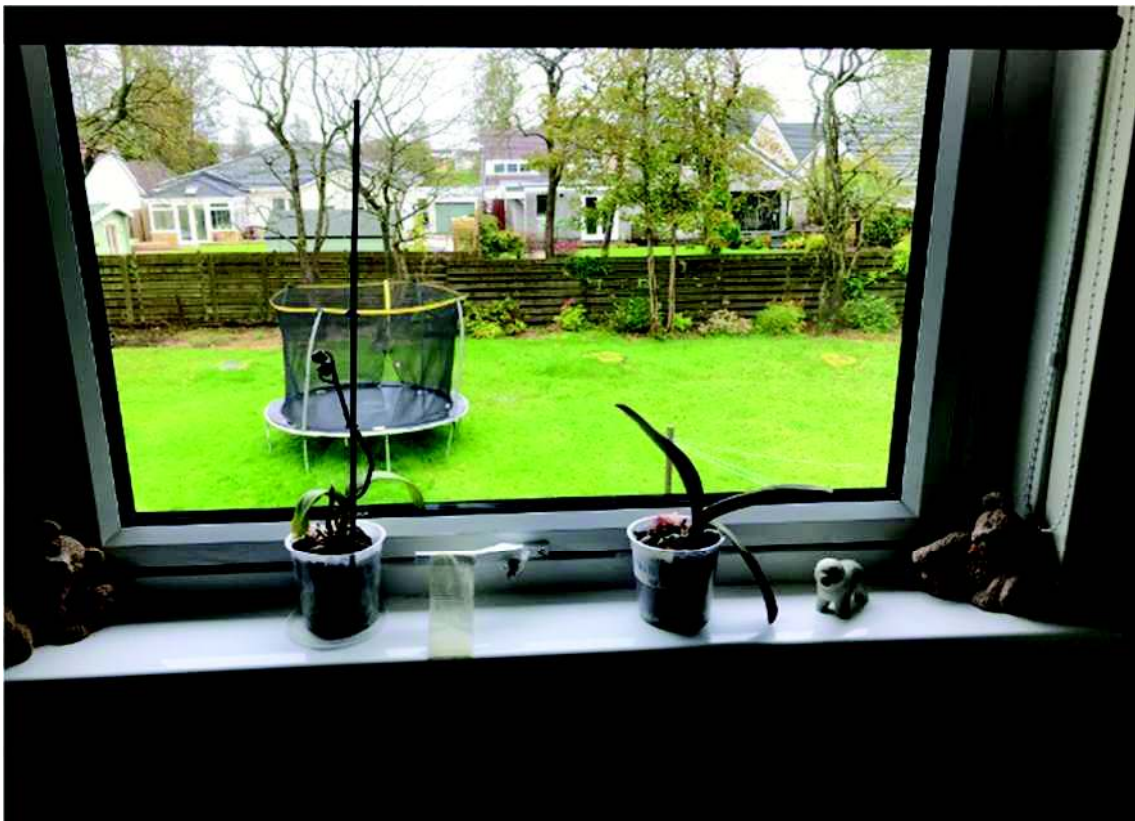
The upper hall window no longer operates correctly and replacement parts are not available (photo 27). The window is currently sealed internally to hold closed. This window should be replaced.

27 Window in upper hallway does not lock/close securely - taped closed at present. Replacement required

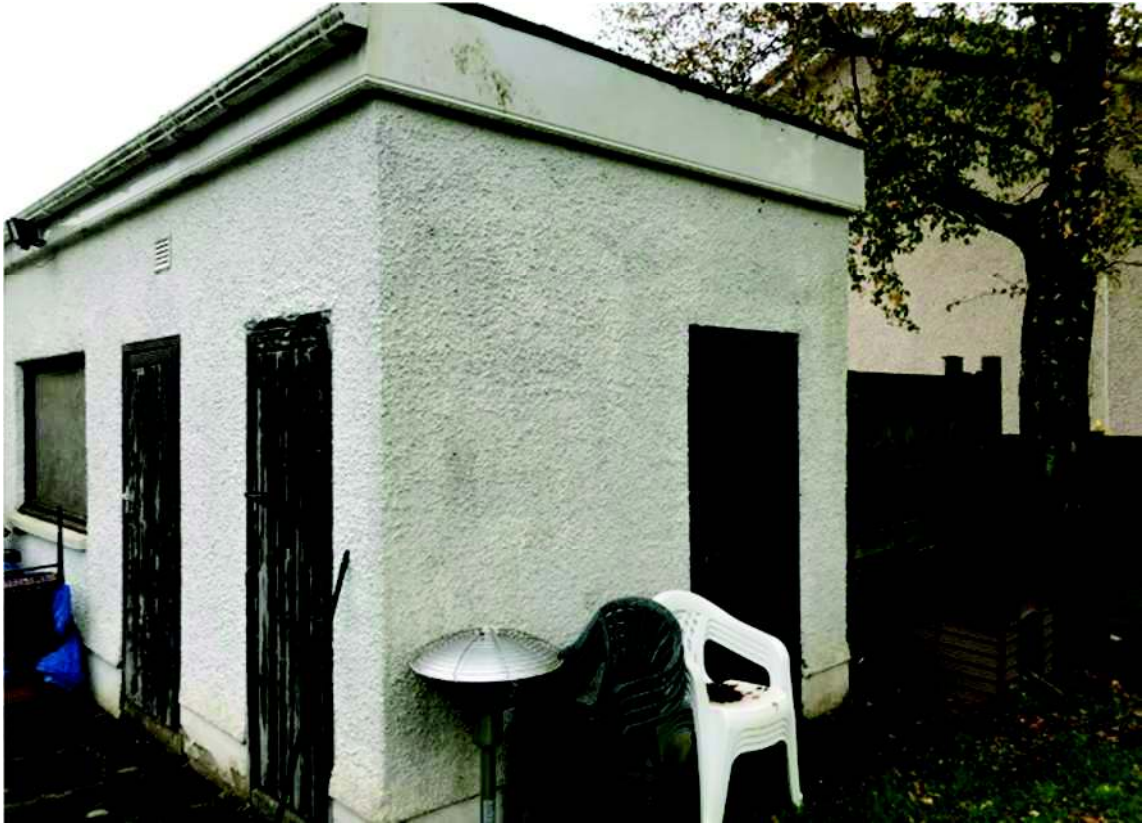
28 External woodwork to be redecorated
